# Seismic evaluation of Romanian traditional buildings with timber frame and mud masonry infills by in-plane static cyclic tests

Andreea Dutu<sup>a,\*</sup>, Mihai Niste<sup>a</sup>, Iulian Spatarelu<sup>a</sup>, Daniel Ioan Dima<sup>a</sup>, Shoichi Kishiki<sup>b</sup>

<sup>a</sup> Technical University of Civil Engineering Bucharest, Romania

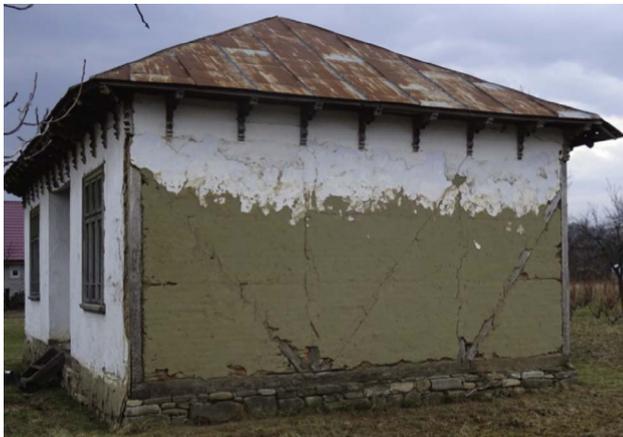
Fig. 12. Upper structure of the house (Fig. 9 was made after this house).

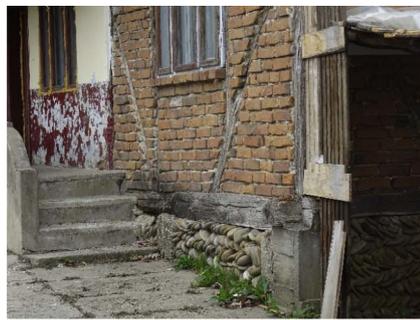
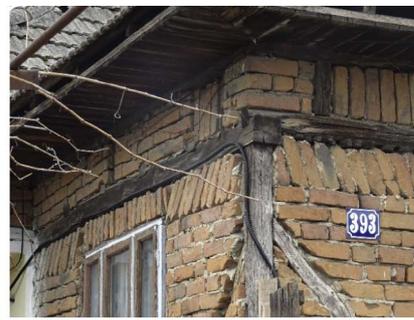
a. The foundations are made only from stone (river rocks)

b. The diagonals are stopped below the upper connection between beam and column, and the last row of bricks is laid in an inclined position

Fig. 15. Details of traditional house with timber skeleton and brick masonry infill (Type 1) from Teiș village, Dâmbovița county.

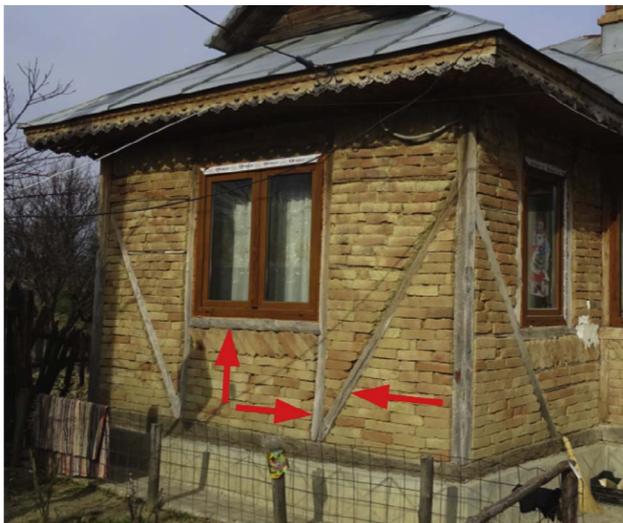
Fig. 17. Structural timber elements in “paianta” houses: columns and braces which do intersect at the bottom.

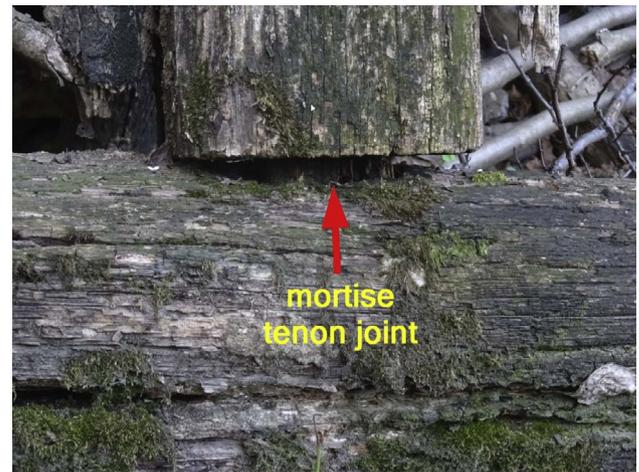
Fig. 21. Mortise tenon connection.

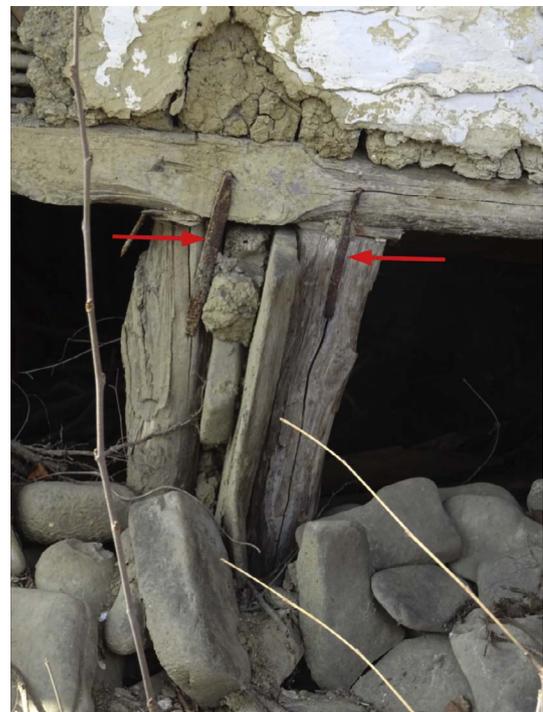
Fig. 22. Detail of pile foundation connected to the bottom beam with steel clamps.

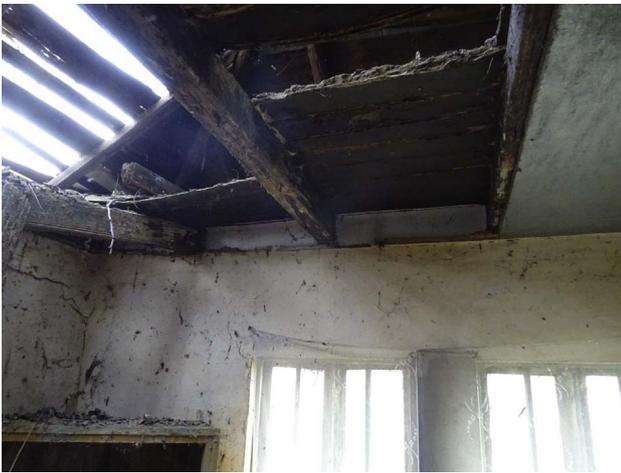
Fig. 23. Detail of floor in an abandoned house.

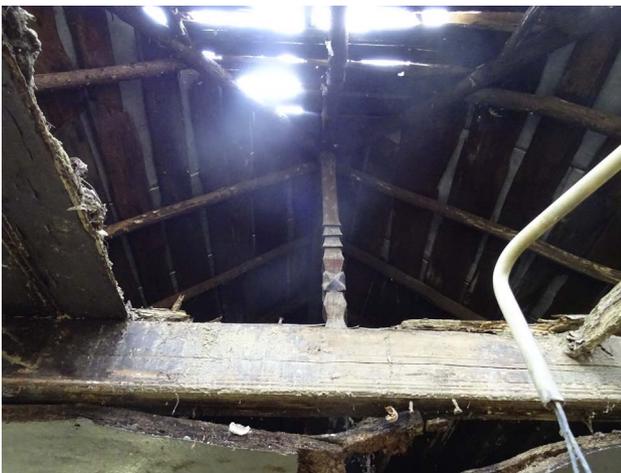
Fig. 24. Detail of roof structure in an abandoned house.

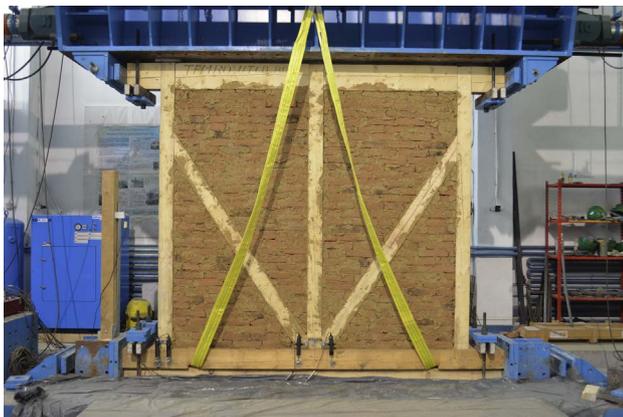
Fig. 29. Position of the wall in the reaction frame.

Tests were conducted in a static cyclic regime on a self-balanced reaction frame provided with two horizontal hydraulic jacks with the maximum capacity of 1000 kN (228 mm stroke) and one vertical hydraulic jack with the maximum capacity of 2000 kN (100 mm stroke). Test setup is shown in Fig. 28 and Fig. 29.

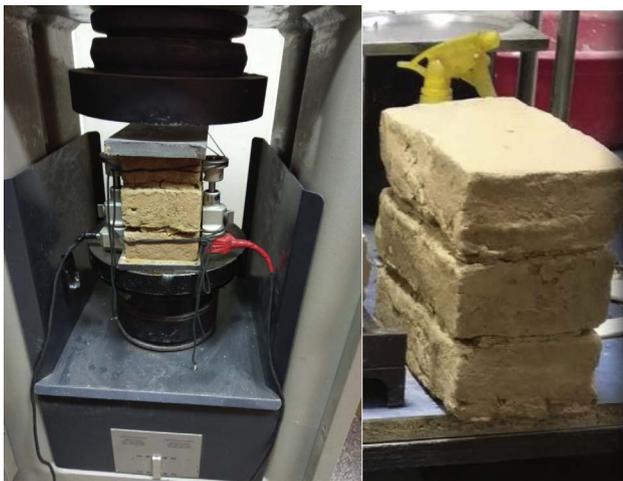
Fig. 30. Layout of specimen and compression test on masonry prisms.

Average compressive strength for earth (mud) was obtained as 2.6 MPa. Compression tests were also conducted for masonry prisms made of mud bricks with layout as in Fig. 30. The average compressive strength was 1.86 MPa while the Young's modulus, determined as the secant stiffness corresponding to 1/3 of the maximum strength value, was 0.6 GPa. The timber is Romanian fir (Pinaceae), with an average specific weight of  $385 \text{ kg/m}^3$  and an average moisture content of 15%.

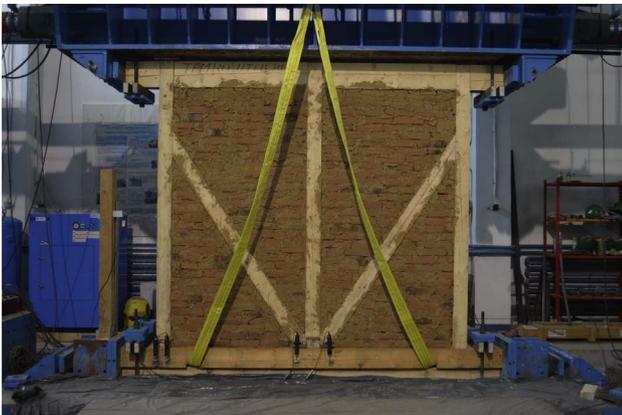
Fig. 35. S1 before the start of the test.

Figs. 35 and 36 show the wall specimen in the undamaged state and, respectively, after the last cycle of test. The S1 specimen didn't fail until 0.053 rad (~5.3% drift) when the stroke of the jack reached the limit. It did not show any significant damage except local compression perpendicular to grain in the upper cross-halved connections (Fig. 37) and pull-out of the braces which on reverse cycles went back into original

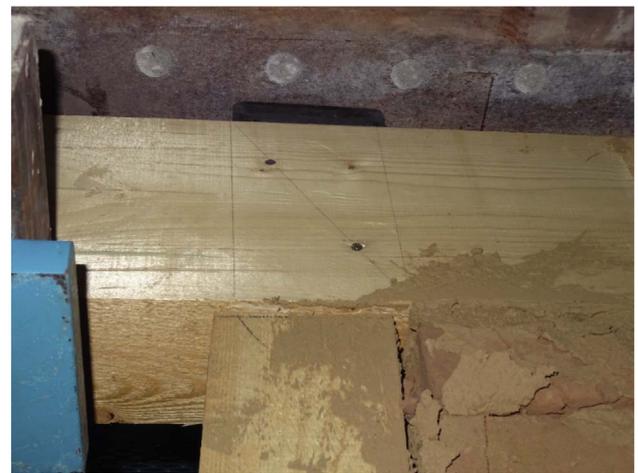
Fig. 40. Upper marginal connection with imperfect executed connection (initial defect).

positions (Fig. 39). The uplift in the bottom connections were not significant (Fig. 38 ). Some initial defects from the execution did not influence the behavior (Fig. 40).

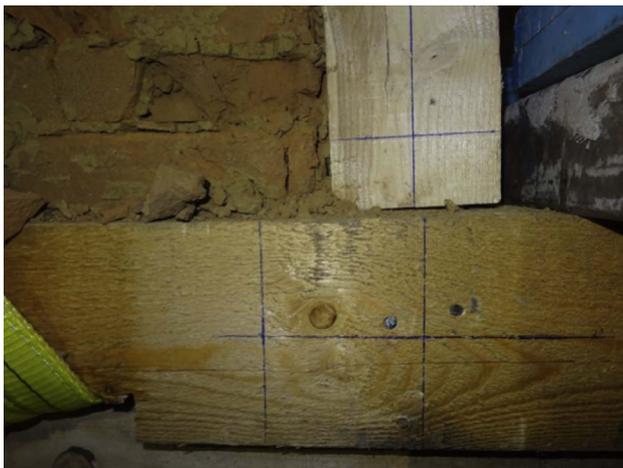
Fig. 38. Bottom marginal connection with small uplift.

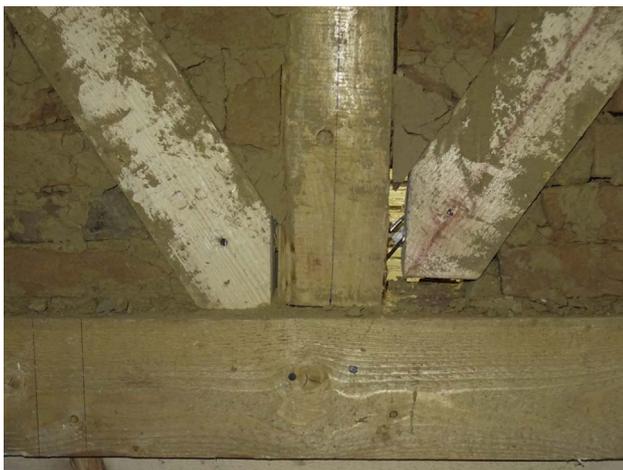
Fig. 39. Bottom middle connection with significant pull-out of one diagonal brace.

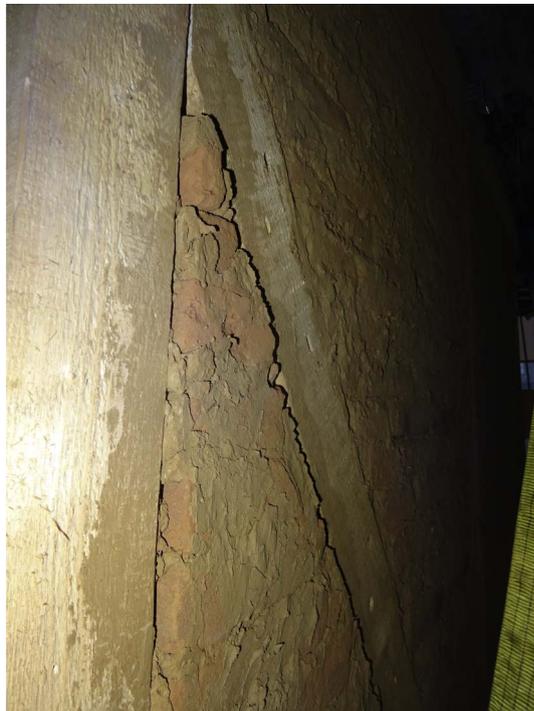
Fig. 42. Out of plane of the infill.

Out of plane behavior of the infill was significant (Figs. 41 and 42 ), starting in the areas below the diagonal brace. Mud mortar was initially cracked due to the shrinkage from the drying, as in the real situation. This is a common property of the mud, and due to this, every year, the owners usually make small repairs with new mud, applying a new layer and thus infilling the cracked walls (due to shrinkage). With the detachment of the infill from the frame, due to the large deformation at the top, the infill can easily fall).

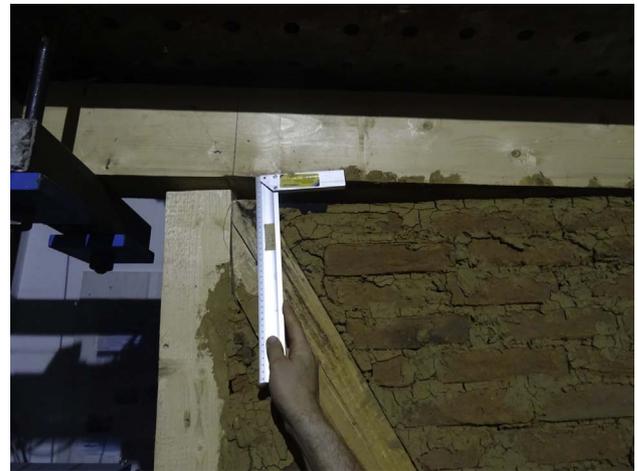
Fig. 45. Upper marginal timber connection significant uplift.

Figs. 43 and 44 show the wall specimen undamaged and, respectively, in the last cycle of the test. The S2 specimen didn't fail until 0.048 rad (~ 5.6% drift) when the stroke of the jack reached the limit. It showed significant uplift in the connections (Figs. 45 and 46) and pull-

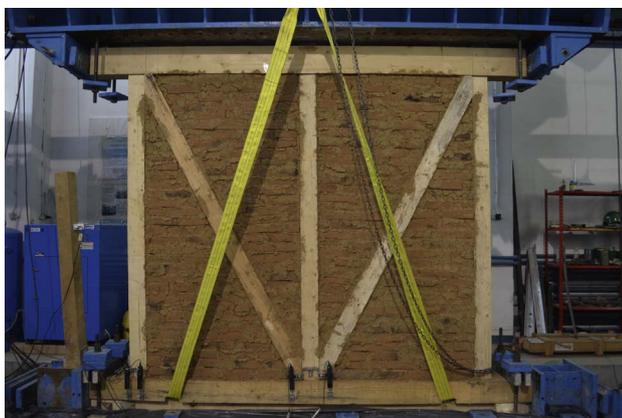
Fig. 43. S2 before the start of the test.

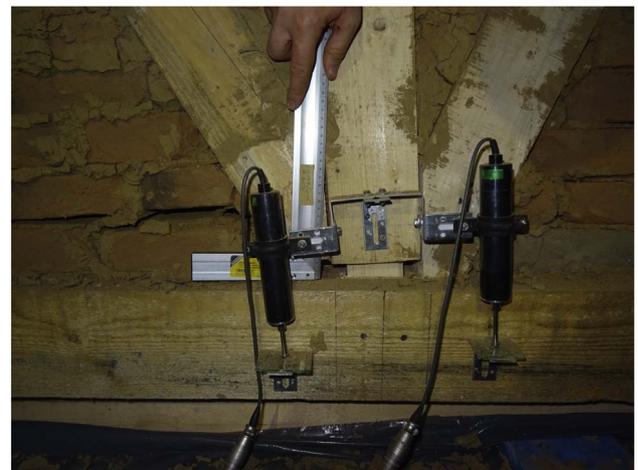
Fig. 46. Bottom middle connection with significant pull-out of one diagonal brace, uplift of central column and infill crack.

out of the braces which on reverse cycles went back into original positions (Fig. 46). The reverse input of the tenon into the mortise in the beams also influenced the hysteresis, giving some stiffness immediately after unloading (Fig. 32). Out of plane behavior of the infills was significant (Fig. 47), similar to S1 specimen.

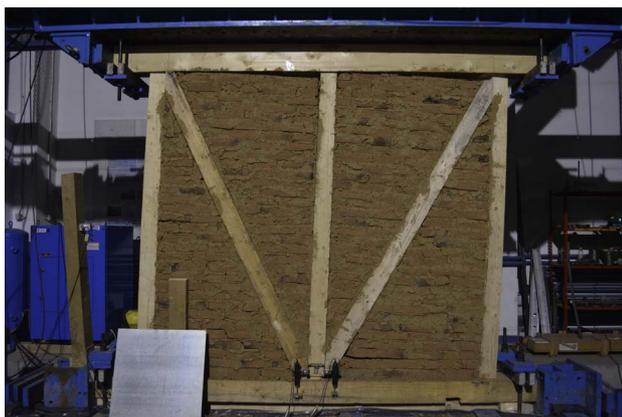
Fig. 44. S2 in the last cycle of the test, at 4.8% shear angle [rad].

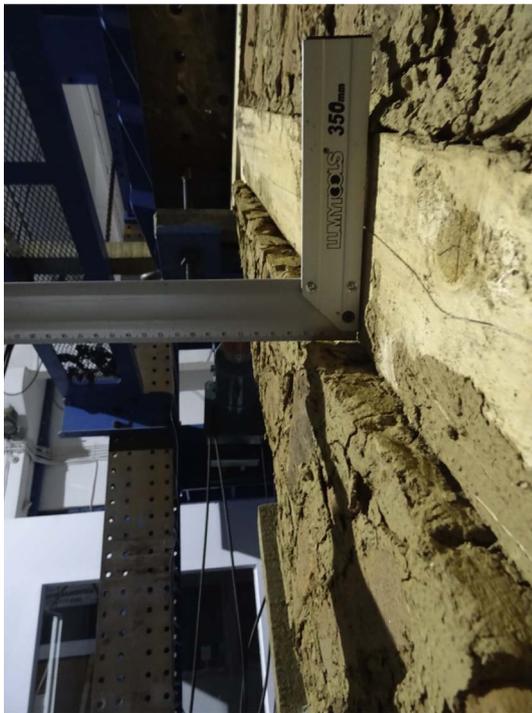
Fig. 47. Out of plane behavior of the infill.
